(Certificate of conformity with technical requirements in:)
API STANDARD 607 SEVENTH EDITION, JUNE 2016

Certificate No.:270873

Test Report

(Valve fire test according to API STANDARD 607 SEVENTH EDITION, JUNE 2016.)

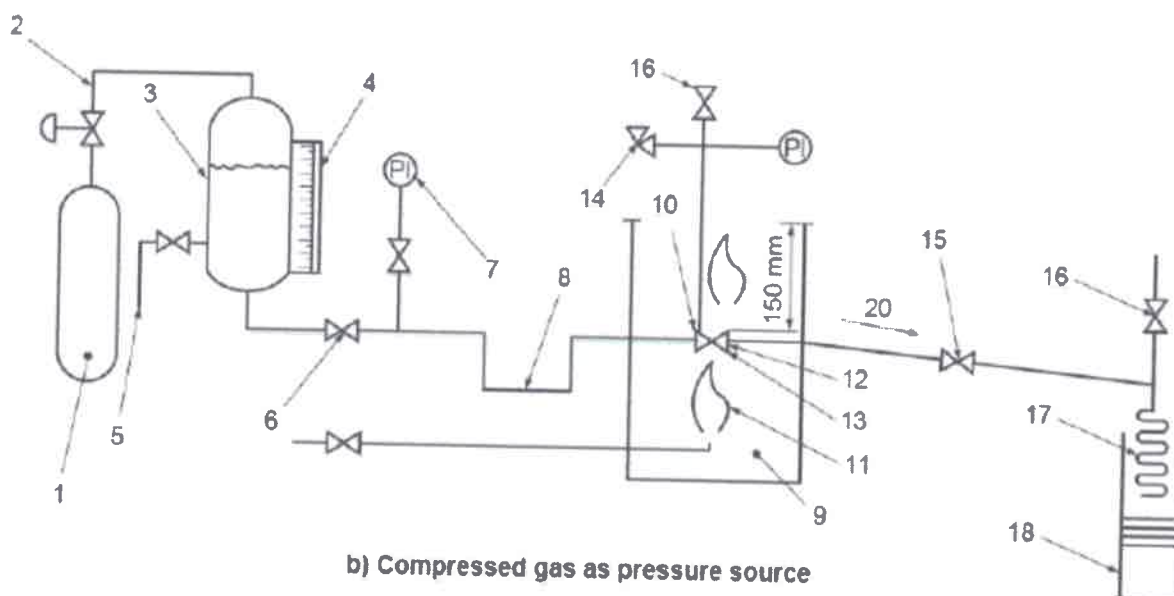
Figure 1. Typical Fire-Test System Using Compressed Gas as the Pressure Source

The test equipment was verified by TÜV SÜD inspector according to requirements of API STANDARD 607 SEVENTH EDITION, JUNE 2016. Para.5.3 and found satisfactory. The detail arrangement of the fire-test equipment is shown below:

| 1. Pressure source | 10. Test valve mounted horizontally with stem in horizontal position (see 5.6.1) | 19. Check valve |
| 2. Pressure regulator and relief | 11. Fuel gas supply and burner | 20. Slope |
| 3. Vessel for water (6in.) | 12. Calorimeter cubes (see 5.3.2) | 21. Clearance: 150 mm |
| 4. Calibrated sight gauge | 13. Flame environment and body thermocouples (see 5.3.2) | |
| 5. Water supply | 14. Pressure gauge and relief valve (see 5.3.2) | |
| 6. Shut-off valve | 15. Shut-off valve | |
| 7. Pressure gauge | 16. Vent valve | |
| 8. Piping arranged to provide vapor trap (see 5.3.2) | 17. Condenser | |
| 9. Enclosure for test | 18. Container (see 5.3.2) | |

- 6.1 The thermocouples and calorimeters were installed properly according to Figure 1,2,3,4 in API 607. Two thermocouples (part 13) are installed to measure flame temperature, one is located under valve body, another is located under valve stem, both within 1". Two calorimeters (part 12) are positioned to the same place as the thermocouples do.
- 6.2 The test system including test valve (part 10) was cleaned through by water before testing. All air was purged from test valve and testing system by water.
- 6.3 The test system was pressurized to 2.8 MPa after the test valve and system upstream of valve have been completely full of water and system downstream of the test valve have been completely empty of water. The system and test valve were carefully checked for leakage when the test pressure was held at 2.8 MPa. No leakage was found on system and test valve.
